Manhole Inspection Summary

Manhole # S29OO1015MH

Location Address: **COLD SPRING LN**

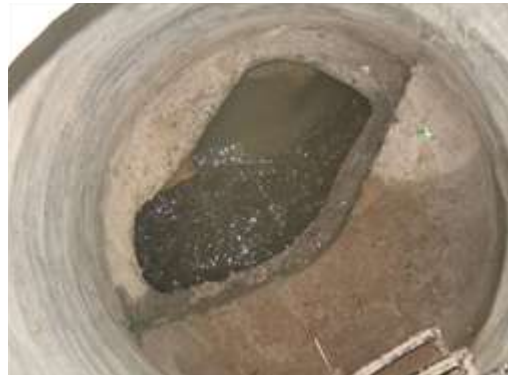
Top View

Bench ☒ Exists Material: **Unknown** ☐ Parged ☒ **Debris** (not Condition related)

Bench debris.

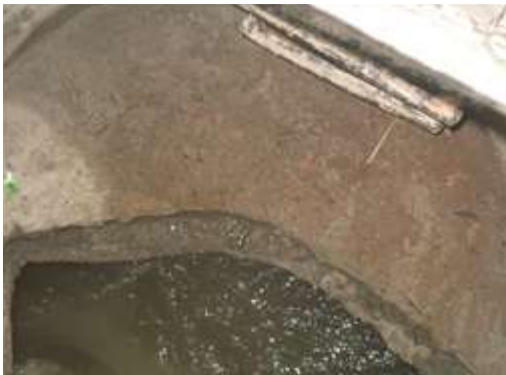
Defect

Infiltration: ☐ None ☐ Joint ☐ Cracks ☐ Mortar ☐ Roots ☒ **Wall**

Barrel infiltration.

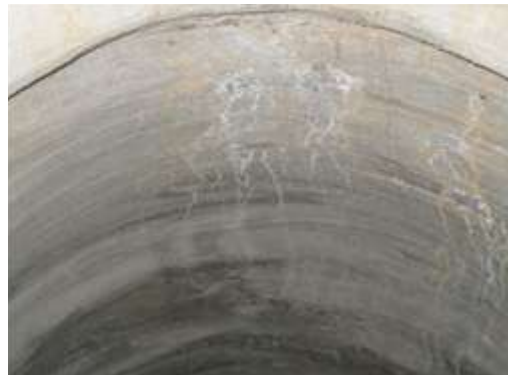
Defect

Infiltration: ☐ None ☒ **Joint** ☐ Cracks ☐ Mortar ☐ Roots ☐ Wall

Infiltration: ☐ None ☐ Joint ☐ Cracks ☐ Mortar ☐ Roots ☒ **Wall**

Adjustment and Corbel infiltration.

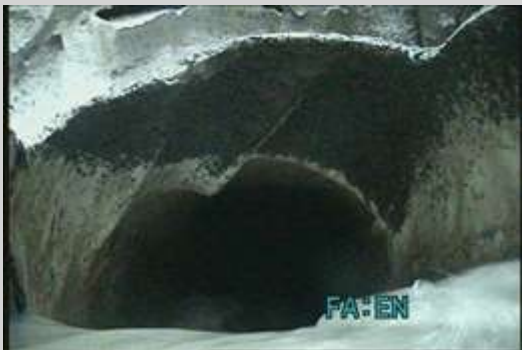
24 in. Circular Gravity Sewer Pipe Out @ 12 O'Clock

Infiltration: **Evidence** Pipe Seal Cond: **Unknown**

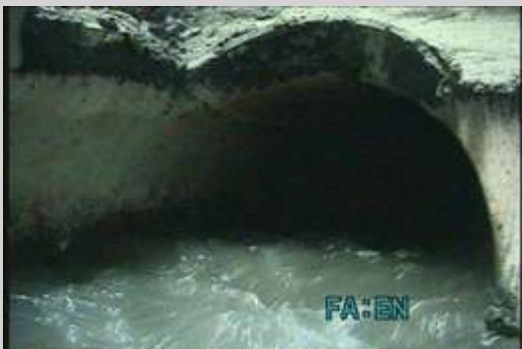
20 in. Circular Gravity Sewer Pipe In @ 7 O'Clock

Infiltration: **Evidence** Pipe Seal Cond: **Unknown**

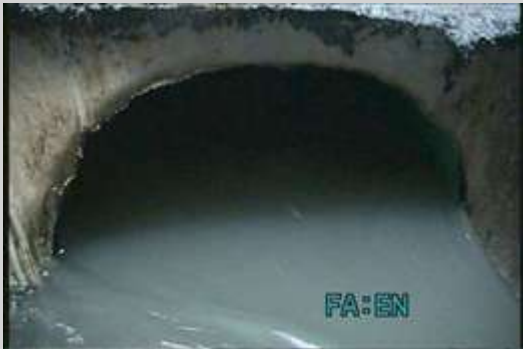
18 in. Circular Gravity Sewer
Pipe In @ 8 O'Clock

Infiltration: **Evidence** Pipe Seal Cond: **Sound**
